## Appendix B

### STRUCTURAL BUILDING ASSESSMENT

On October 27, 2009, CHA, Inc. performed a visual structural assessment of the buildings located at the Ellington Airport in the Town of Ellington, Connecticut. The assessment included seven facilities of varied construction and occupancy, and number of structures. The purpose of the assessment was to identify structural deficiencies and potential need for rehabilitation. Table B-1 below is a brief description of each structure, with a list of deficiencies and recommendations; Figure 1-1 identifies the location of the buildings. A planning cost estimate is provided for the repairs for each structure listed within the Airport Capital Improvement Plan in Chapter 2.

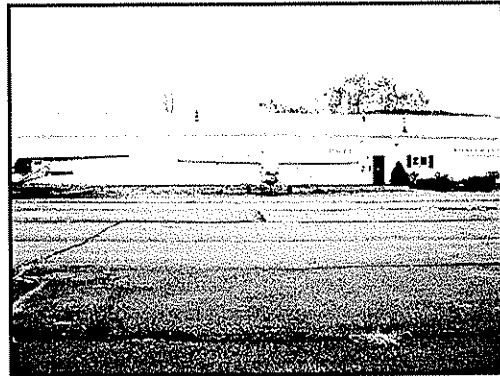
**Helicopter School/Auto Mechanic Facility:**

- Evidence of structural deficiencies to the primary and secondary structural members was not observed.
- The exterior surface of the metal roofing has many areas of corrosion.

- The bottom edge of the metal wall siding has corrosion in several areas.
- The bottom edge of the metal wall siding is dented at several areas.
- The bottom edge of one of the exterior man doors is corroded.

- There are no gutters at the roof. Rain water falls from the roof to the pavement that surrounds the building on three sides, and splashes on to the metal wall siding.

- The roof insulation is torn at the roof ridge in the helicopter maintenance hangar.
- There are several minor cracks in the concrete slab-on-grade in the helicopter maintenance hangar. These cracks were painted and do not appear to be formed recently.

- The ceiling tile at the entrance door to the helicopter hangar is stained which indicates a roof leak.
- There are several small holes in the roof insulation in the automobile repair garage.

- The wall insulation is torn at several locations at the automobile repair garage.
- The bottom edge of the metal wall panels above the hangar door are corroding.
- The bottom edge of the exterior man door is corroding.

- The corroded areas of the exterior metal wall and roof panels should be repaired by removing the rust and repainting. Due to the large number of corroded areas on the roof, the entire roof should be repainted. Repainting the entire wall surface is not warranted. Only those areas of the exterior wall panels that are corroded should be repainted.
- Gutters and downspouts should be installed to control roof drainage. Roof drainage should not be allowed to splash on to the exterior wall panels because this will lead to corrosion.
- Exterior metal wall panels that are dented should be replaced.
- The source of the roof leak at the helicopter hangar entrance door should be identified and repaired. The stained ceiling tile should be removed and replaced to match the existing unstained ceiling tiles.
- The torn roof and wall insulation should be replaced with new insulation.

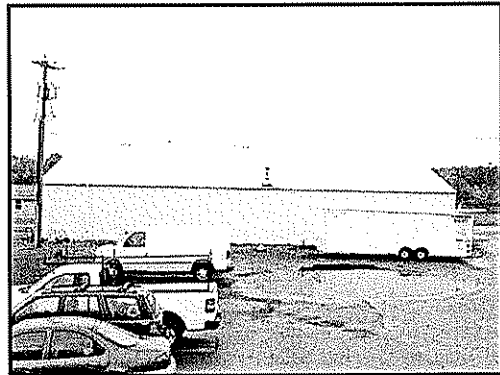
**Aircraft Maintenance Facility:**

- Evidence of structural deficiencies to the primary and secondary structural members was not observed.
- The exterior surface of the metal roofing has many areas of corrosion.
- The bottom edge of the metal wall siding has corrosion in several areas.
- The metal flashing at the bottom of the wall panels is corroded.

- The exterior metal wall panels are dented at the bottom of the walls. The denting is severe at the west wall where many of the joints between the panels are displaced and out of alignment. This condition may allow water to enter the building.
- There are no gutters at the roof. Rain water falls from the roof to the pavement that surrounds the building on two sides, and splashes on to the metal wall siding
- The steel columns at each end of the hangar door have mild corrosion near the floor. Delamination was not observed.

- The corroded areas of the exterior metal wall and roof panels should be repaired by removing the rust and repainting. Due to the large number of corroded areas on the roof, the entire roof should be repainted. Repainting the entire wall surface is not warranted. Only those areas of the exterior wall panels that are corroded should be repainted.
- Gutters and downspouts should be installed to control roof drainage. Roof drainage should not be allowed to splash on to the exterior wall panels because this will lead to corrosion.
- Exterior metal wall panels that are dented should be replaced.
- The corroded metal flashing at the base of the wall should be repaired by removing the rust and repainting.
- The corrosion on the steel columns adjacent to the hangar door should be removed, and the columns repainted.

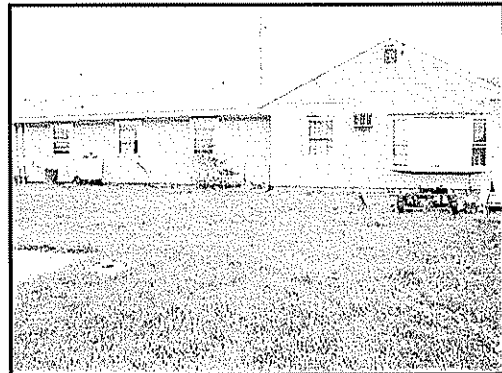
**Office Building:**

- The asphalt roof shingles are deteriorating.
- The painted wood fascia boards and soffits are deteriorated. Wood rot was observed in many locations on these members.

- The joints of the vinyl siding were coming apart at several locations. This condition can allow water to penetrate the exterior and potentially cause deterioration of the wood sheathing.
- Many of the wood windows are deteriorating or rotting. The bay window at the west wall of the building is in very bad condition.
- The attic vents at the south gable end wall is deteriorating. A vent was not observed at the north gable end wall.
- Ridge vents were not observed at the roof.
- Vents at the wood soffits are very small and are probably inadequate.
- A rusting propane tank is located against the west wall of the building.

- Replacement of the asphalt roof shingles may be necessary within the next 5 years. A ridge vent should be added to help in providing proper attic ventilation.

- All of the wood soffit boards should be removed and replaced with ventilated vinyl panels to provide adequate attic ventilation. The deterioration of the soffits suggests that deterioration of the wood roof shingles and wood framing members may be occurring. The attic space should be accessed so that an inspection of these members can be performed.

- The interior spaces that were not accessible should be inspected.
- All wood fascia boards should be removed and replaced with aluminum trim.
- The separated joints in the vinyl siding should be repaired.

- All paint should be removed from the wood windows so that they can be repainted to stop the deterioration. If the deterioration is not stopped soon, it is likely that all windows will require replacement.

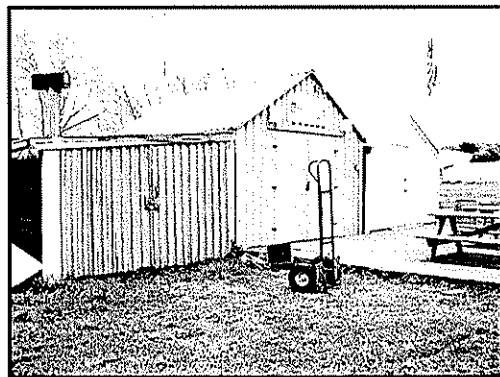
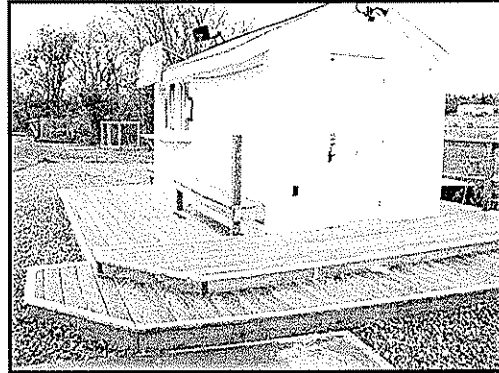
**Sky Diving Facility:**

- The plywood wall at the lean-to structure is deteriorated and in poor condition.
- The wood roof deck at the south end of the shed structures felt soft and spongy in several areas. The green carpet material is probably trapping moisture against the wood framing and causing decay.
- The southern bridge crossing the stream has no handrails.
- The shed structure used as office space has two different colors of asphalt roof shingles.
- One of the wood framed sheds has vinyl siding which is mold stained at the north wall.
- The paint at the north wall of the metal shed with the sloped roof is failing at the north wall.

- The deteriorated plywood at the metal lean-to structure should be replaced with new plywood. The new plywood should either be painted or be pressure treated to resist decay.
- The green carpet material should be removed from the wood deck at the south end of the shed structures. All soft and deteriorated wood deck framing should be removed and replaced with new pressure treated wood.
- Handrails should be installed at the southern bridge crossing the stream. The handrails should be strong enough to resist the horizontal loading required by the local building code.
- The failing paint should be removed from the metal shed with the sloped roof. This building should then be repainted.

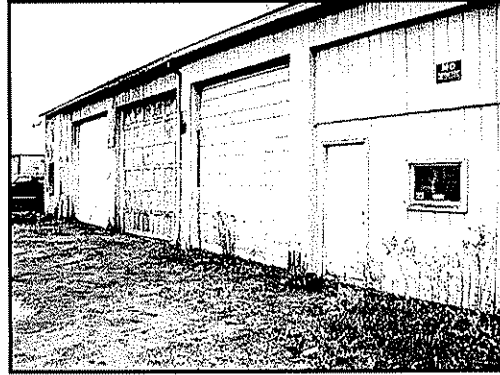
**Private Storage Building:**

- The roof ridge is very uneven, which indicates that the roof members have experienced large differential deflections.
- The gutter on the east side of the building is pulling away from the roof.
- The asphalt roof shingles are in poor condition.
- The exterior wood siding is in poor condition. The wood siding extends down to the finished grade, and is deteriorating at this location.
- There is very little roof insulation. The roof insulation that does exist is in poor condition and is hanging from the roof structural members.
- It was not possible to inspect the west exterior wall because of the brush and debris that were against this wall.

- Additional study should be performed to determine the cause of the roof deflection. The roof structural members should be accessed with a lift for further study.
- The gutters should be replaced with new gutters and downspouts. Splash blocks should be provided at each downspout.
- The deteriorated asphalt roofing should be replaced.
- The roof should be properly insulated, in addition to the walls.
- The deteriorated areas of the wood siding at the bottom of the walls should be replaced with pressure treated wood siding because the wood siding is within eight inches of finished grade.

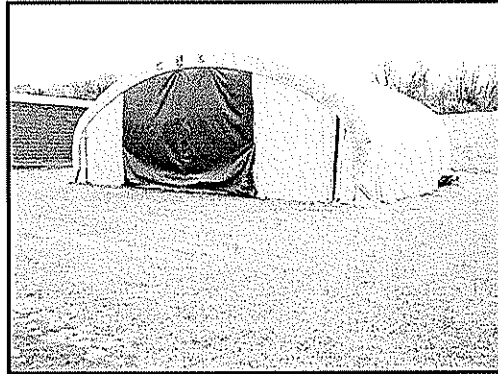
**Private Hangar #1:**

- Evidence of significant structural deficiencies was not observed.
- Several small holes were observed at the top of the fabric covering.

- The holes in the fabric covering should be patched.

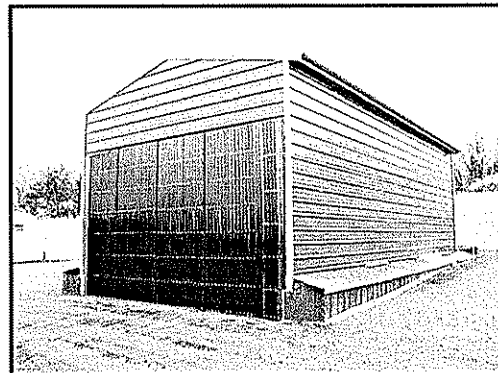
**Private Hangar #2:**

- None

- No structural deficiencies were observed that require recommendations. Regular maintenance should be performed on the hangar to maintain its condition.

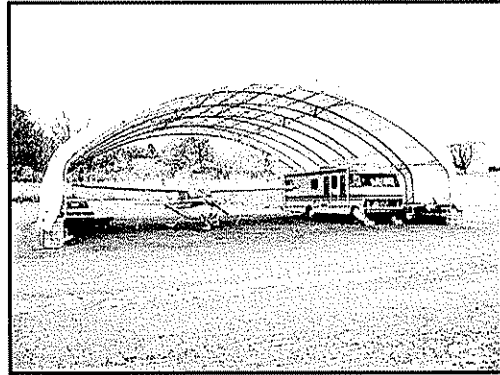
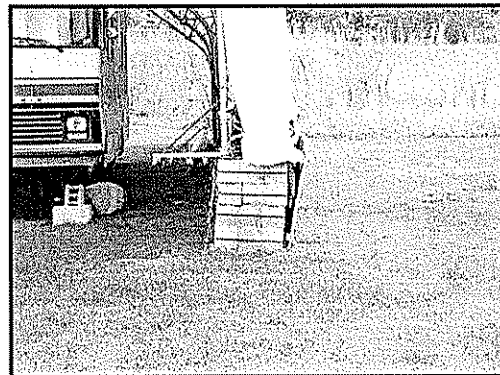
**Private Hangar #3:**

- The CMU piers were constructed without any mortar or grout. The CMU cells that were observable under the plywood bearing plate at the top of the piers were hollow.
- The CMU piers at the south side of the hangar are not plumb and have moved to the south.
- The steel banding strapping the CMU together is rusting. The banding is ineffective at bonding the piers together.
- The plywood bearing plates at the top of the piers are deformed.
- Several of the steel cables anchoring the piers to the soil are loose at the north side of the hangar.
- The arches at the west end of the hangar are loading the piers eccentrically.
- There are several tears and stains at the north end of the hangar.

- The foundation piers are not stable, do not represent good construction practice, and should be rebuilt. If they are rebuilt from masonry, the blocks should be mortared together, and the cores of the CMU should be grouted solid. The piers should be designed by a professional engineer licensed in Connecticut for all loading required by the local building code. The pier design should include the connection of the arch to the pier for all forces required by the local building code.
- The torn fabric should be patched.
